# MICROCHIP PIC18F2420/2520/4420/4520

## PIC18F2420/2520/4420/4520 Rev. B2 Silicon Errata

The PIC18F2420/2520/4420/4520 Rev. B2 parts you have received conform functionally to the Device Data Sheet (DS39631C), except for the anomalies described below. Any Data Sheet Clarification issues related to the PIC18F2420/2520/4420/4520 will be reported in a separate Data Sheet errata. Please check the Microchip web site for any existing issues.

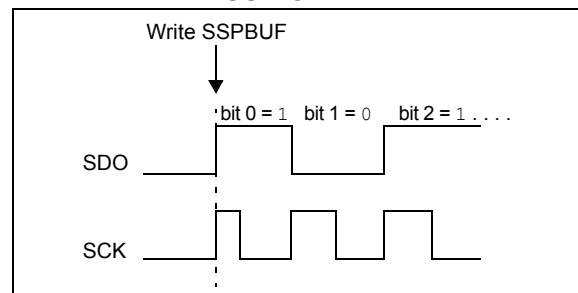
**FIGURE 1: SCK PULSE VARIATION USING TIMER2/2**

When the SPI is using Timer2/2 as the clock source, a shorter than expected SCK pulse may occur on the first bit of the transmitted/received data (Figure 1).

To avoid producing the short pulse, turn off Timer2 and clear the TMR2 register, load the SSPBUF with the data to transmit and then turn Timer2 back on. Refer to Example 2 for sample code.
