## PIC16C63A Rev. A Silicon Errata Sheet

The PIC16C63A (Rev. A) parts you have received conform functionally to the Device Data Sheet (DS30605A), except for the anomalies described below.

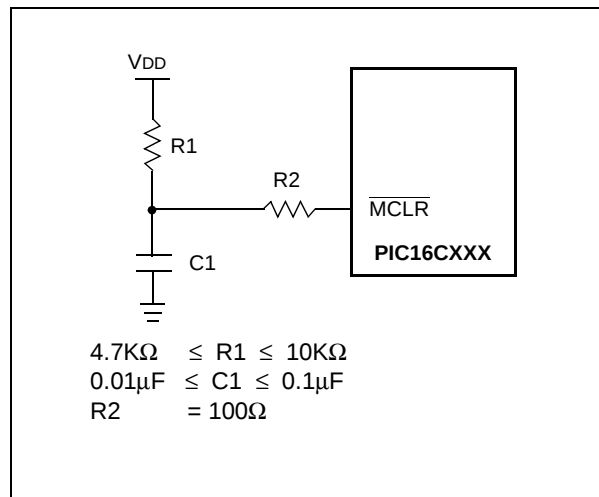
**FIGURE 1:  $\overline{\text{MCLR}}$  EXTERNAL CIRCUIT**

### 1. Module: RESET

The minimum specification for the  $\overline{\text{MCLR}}$  must be met in order to RESET the PIC16CXXX. If a  $\overline{\text{MCLR}}$  pulse occurs that is less than the minimum specification (parameter #30), improper device operation can occur.

If the minimum specification cannot be met, then an external circuit must be used to insure that any pulse width less than the specification will be filtered before it reaches the  $\overline{\text{MCLR}}$  pin.

A possible circuit is shown in Figure 1. Proper design validation needs to be done to ensure desired operation over the applications operating conditions

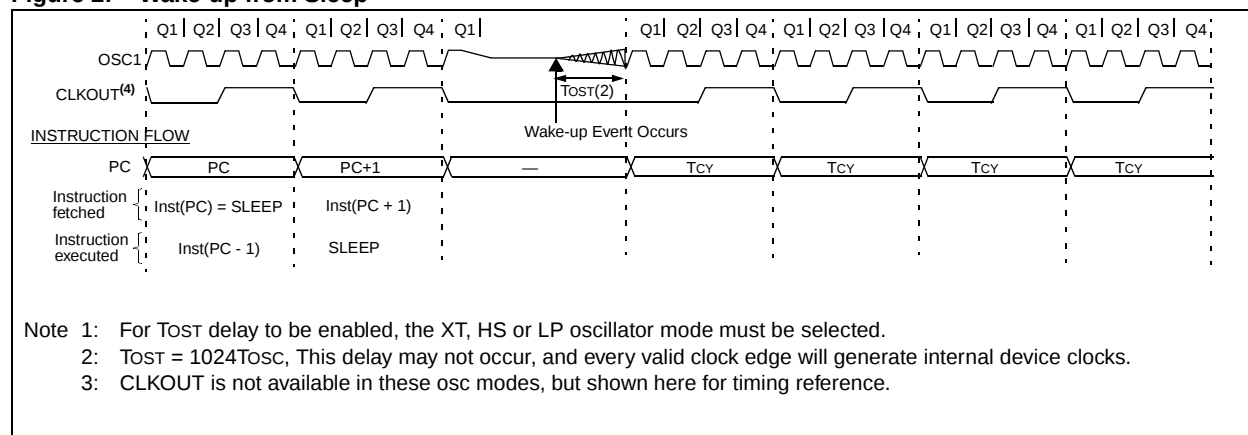
**Figure 2: Wake-up from Sleep**

The Oscillator Start-up Timer ( $T_{OST}$ ) delay may not occur when the device wakes-up from sleep.

Figure 2 shows the start-up of the crystal after the event that causes the device to wake up from sleep mode (as specified in device data sheet). The start-up time ( $T_{OST}$ ) may not occur.

In applications where time based measurements are started immediately after wake-up from sleep, the suggested work around should be implemented.

After the SLEEP instruction, do a software delay of 256  $T_{CY}$  (same as 1024  $T_{OSC}$ ). At the Reset and Interrupt vector addresses, test to see if the device woke from sleep (the  $\overline{TO}$  and  $\overline{PD}$  bits), and if the device did wake from sleep, ensure that the total cycle delay is 256  $T_{CY}$ .

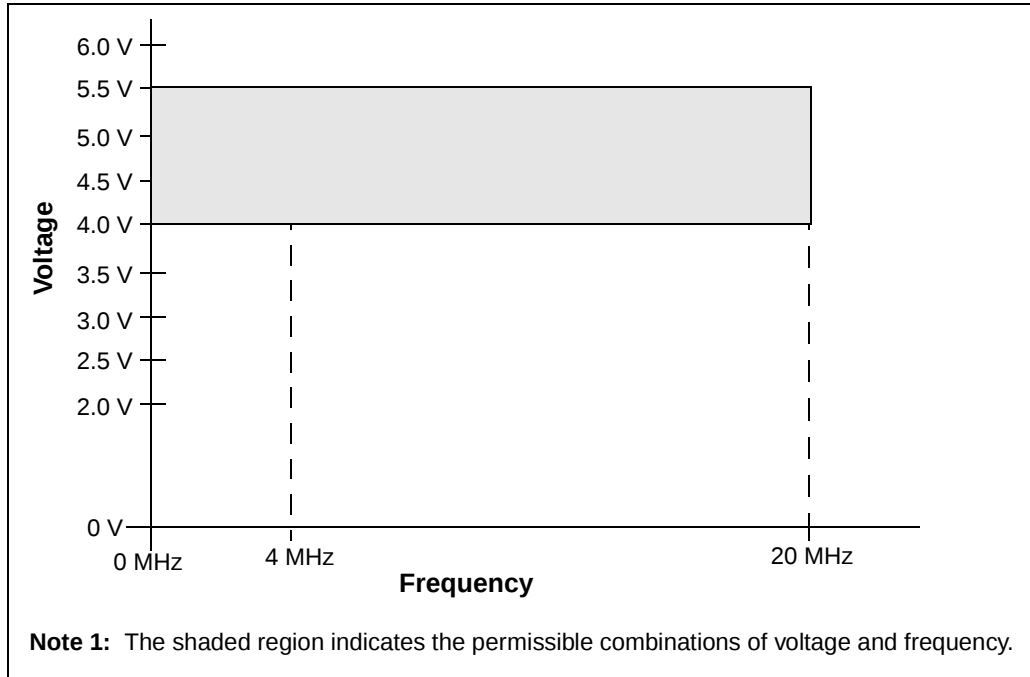
**Figure 3: PIC16CXXX Voltage-Frequency Graph**

1. Figure 3 and Figure 4 are additions to the data sheet to show the area of operation. These figures replace the Cross Reference of Device Specs for Oscillator Modes Table in the Electrical Specification section.

Figure 3 shows the voltage vs. frequency operation for the PIC16CXXX devices. Devices marked with a "-04" operate up to 4 MHz, while devices marked with a "-20" operate up to 20 MHz. The entire shaded region is the valid operating region.

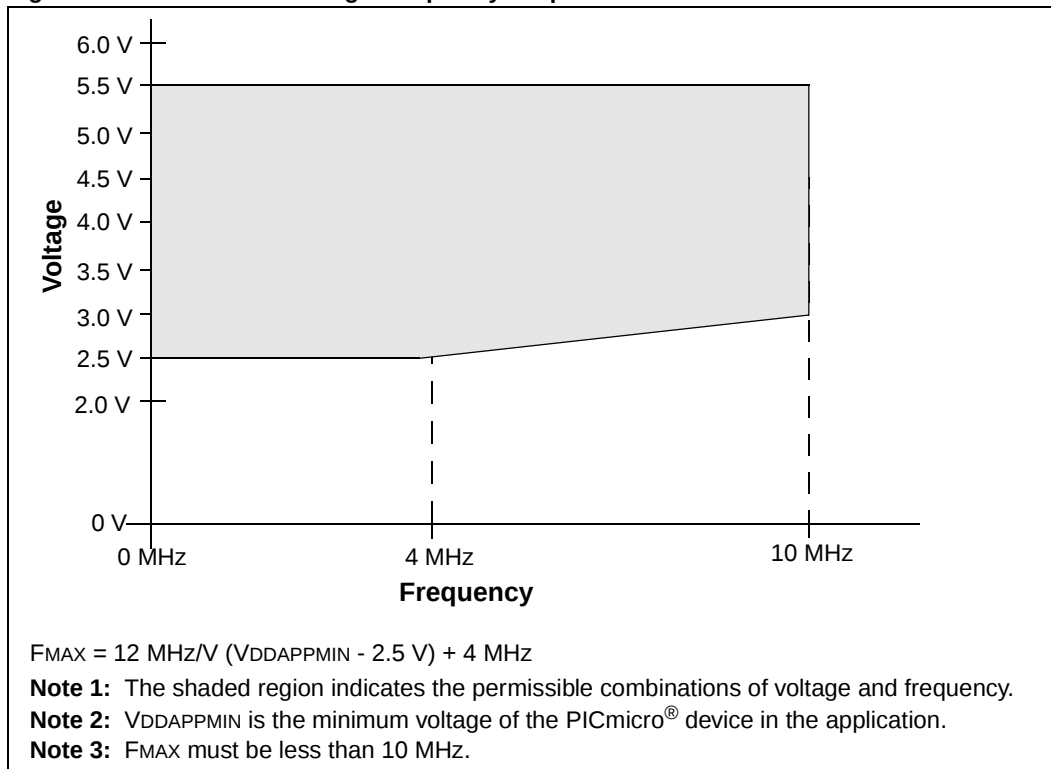
**Figure 4: PIC16LCXXX Voltage-Frequency Graph**

Figure 4 shows the voltage vs. frequency operation for the PIC16LCXXX devices. The devices marked with a "-04" operate up to 4 MHz at the minimum supplied voltage. The devices also operate at a higher frequency (10 MHz) and at a higher voltage (3V). The entire shaded region is the valid operating region.
