**TMS320LF2407A, TMS320LF2406A, TMS320LF2403A,
TMS320LF2402A DSP Controllers
Silicon Errata**

SPRZ002E
July 2001
Revised July 2004

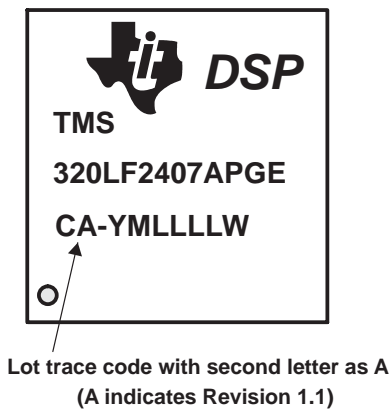
Figure 1. Example, Lot Trace Code for TMS320LF2407A (PGE)

The device revision can be determined by the lot trace code marked on the top of the package. The location of the lot trace code for the PGE package is shown in Figure 1.

Second Letter in Prefix of Lot Trace Code	Silicon Revision	Comments
A (second letter in prefix is an "A")	Indicates Revision 1.1	This silicon revision is available as TMS.
